Experimental evaluation of shear and compression strength of masonry wall before and after reinforcement: deep repointing

M. Corradi^{*1}, C. Tedeschi², L. Binda³ and A. Borri⁴

Keywords: masonry, shear strength, reinforcement, deep repointing

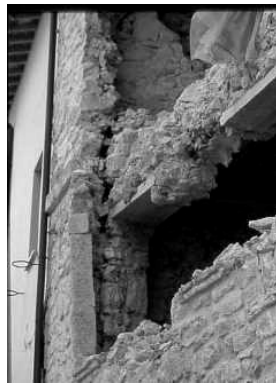
Figure 1 Double leaf wall

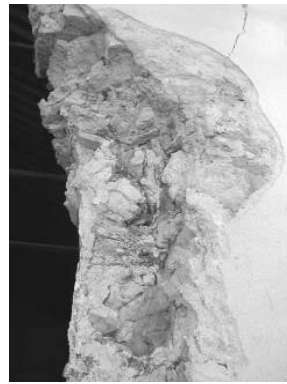
Figure 2 Effect of eccentric loading due to RC tie beam positioning.

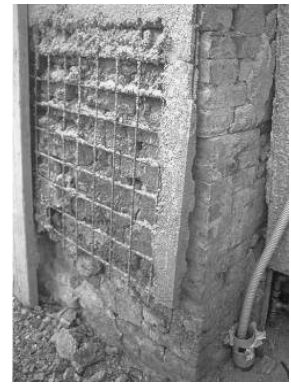
Figure 3 Only some spots were injected in the case of this wall with a very low percentage of voids.

The morphology of the walls suggested that in some cases repair by injection were not appropriate due to the fact that inside the masonry there was practically loose material and no voids were present [3]. Therefore before applying the technique, appropriate tests were carried out in laboratory on sampled materials and also on site [4].

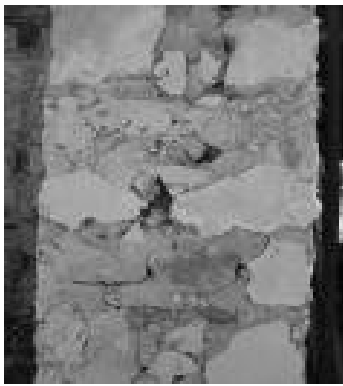
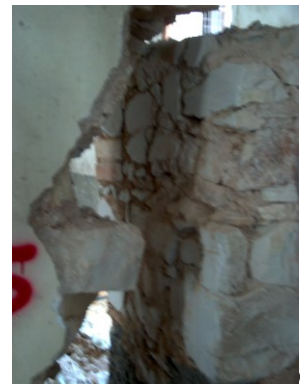
Figure 9 a) Ponte di Postignano bulding; b) Farnetta building; c) Trevi building.

The second building situated in Farnetta was completed at the beginning of the 20th cent. as a rural house. The plan is rectangular with the longest side of 15 m. The building is two floors high with the ground floor used as goods storage subdivided in three rooms (Fig. 9b); the walls are

This large building in Trevi was built at the end of the 19th cent. as a dock for agricultural purposes. The plan is square and the dock is three floors high (Fig. 9c). The masonry is made with two leaves of roughly cut stones with a thickness of 670 mm. The chosen panels had some courses made with bricks at regular spacing. In the internal part of the wall section the mortar filled all the voids between the stones, but no connection was found between the two leaves of masonry.

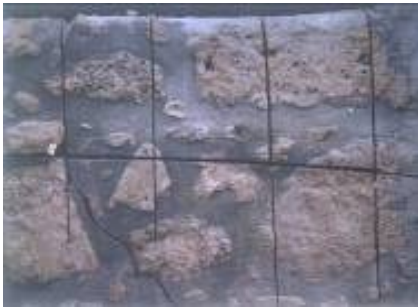
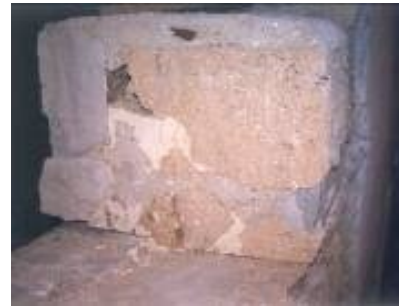
Figure 14 a) Cutting of the panel in different portions; b) depth of penetration; c) good bond between the new and the existing mortar.

After testing of the repaired panels, some of them were cut from the wall and taken to the laboratory in order to control the penetration and diffusion of the repointing and of the injection. Fig. 14a shows the cutting of the panel in different portions which were carefully examined to check the penetration and bonding of the repointing. Fig. 14b and c show, respectively, the depth of penetration and the good bond between the new and the existing mortar. It seems that the deep repointing technique has a higher probability of being successful than the injection technique. Of course the two can be complementary.
